**Flood Control Project Maintenance
Levee Inspections****LMA District Cover Sheet****Spring 2016 Levee Inspection Results****Sacramento Maintenance Yard West Levee Yolo Bypass**

Levee Inspection Report By Mile - Spring 2016

Sacramento Maintenance Yard West Levee Yolo Bypass

Waterway	Bank	Unit Miles	Inspection Start/End	Inspector
Unit No. 01 West Levee	Right	2.73	03/29/2016 03/29/2016	Jai Lor

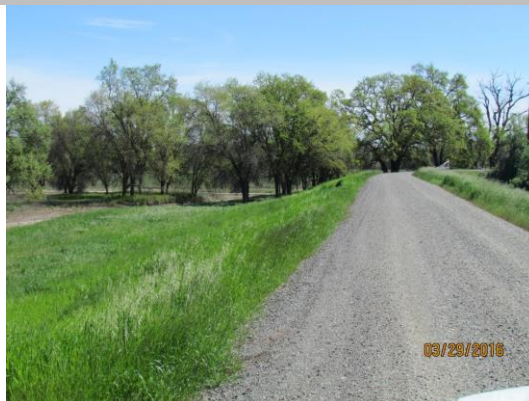
Photo 1 of 1 : SP_2016_ST0011_291_9_20160401_00009.jpg

LM Start	0.02	Rating **	M	Issue No.	9
LM End	2.72	Issue Type +	Ma	Location *	WS
Category	Earthen Levee			GPS Latitude/Longitude	
				Start	End
Item	Vegetation			38.758940 °	38.724229 °
				-121.667306 °	-121.665136 °
DWR ID	DWR_ST0011_01_s_2016_9				
Comment Code					
V1 : Control annual grass and weeds on the levee slopes and easements.					
Inspector Comment

View of the vegetation on the waterward side of the levee looking downstream. Spring 2016.

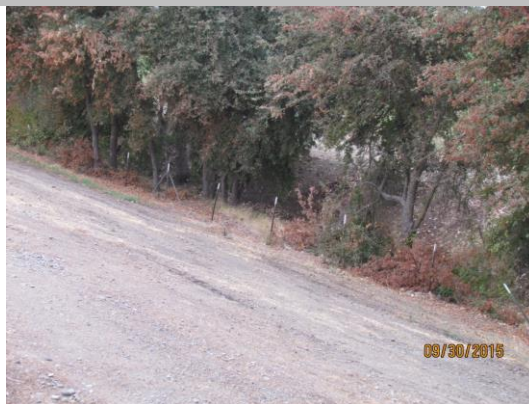
Photo 1 of 1 : SP_2016_ST0011_291_8_20160304_00006.jpg

LM Start	0.94	Rating **	M	Issue No.	8
LM End	1.83	Issue Type +	En	Location *	LS
Category	Earthen Levee			GPS Latitude/Longitude	
				Start	End
Item	Encroachments			38.747888 °	38.734972 °
				-121.660202 °	-121.660265 °
DWR ID	DWR_ST0011_01_s_2012_8				
Comment Code					
DT : Ditch					
Inspector Comment					
The ditch is at the toe of the levee.

View of the ditch on the landward side of the levee. Fall 2015.

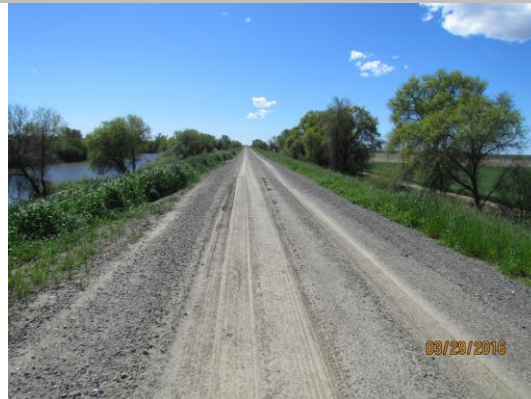
Photo 1 of 1 : SP_2016_ST0011_291_14_20160401_00010.jpg

LM Start	1.46	Rating **	M	Issue No.	14
LM End	2.01	Issue Type +	Ma	Location *	CR
Category	Earthen Levee			GPS Latitude/Longitude	
				Start	End
Item	Crown Surface / Depressions / Rutting			38.740310 °	38.732345 °
				-121.660274 °	-121.660286 °
DWR ID	DWR_ST0011_01_s_2016_14				
Comment Code					
C3 : Add appropriate gravel or road base. Grade and compact.					
Inspector Comment

View of the crown of the levee looking downstream. Spring 2016.

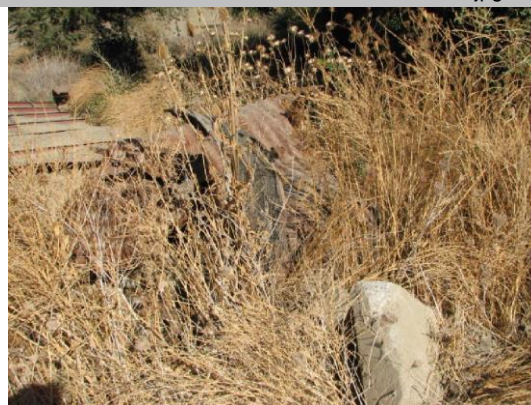
Photo 1 of 2 : UCIP_SP_2016_46746_60276.jpg

LM Start	1.85	Rating **	M	Issue No.	15
LM End	1.85	Issue Type +	En	Location *	CR
Category	Supplemental			GPS Latitude/Longitude	
				Start	End
Item	DWR UCIP Field Study			38.734568 °	38.734568 °
				-121.660264 °	-121.660264 °
DWR ID					
Comment Code					
Inspector Comment					
FS_ID:46746					
DS_ID:17744					
EP_NO: 10284					
Repair Type: Non-Urgent					
Crossing Status: Indicator Found					
UCIP Comments: Found abandoned 42-inch CM pipe on LS berm of the levee. This was abandoned by farmer, how Unknown. need to have verified if removed or concreted					
FIELD_STRUCT_DESC: 42-inch CM drainpipe through levee 25.0 feet below crown. Slide gate on waterward end. (ABO No. 10284 - Hershey).					
O&M manual 127, Revision Year 2011					
FS Date: 10/6/2015 2:32:21 PM

Landside view: an abandoned CM pipe on LS berm of the levee.

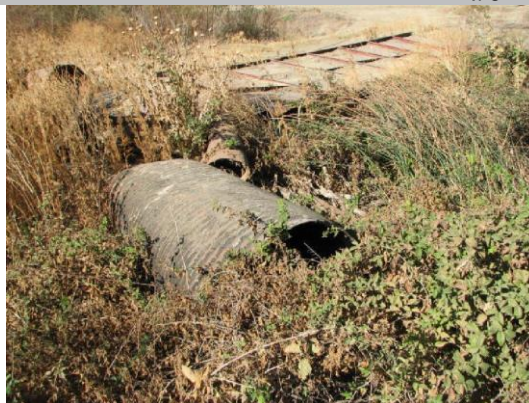
Photo 2 of 2 : UCIP_SP_2016_46746_60275.jpg

LM Start	1.85	Rating **	M	Issue No.	15 (cont)
LM End	1.85	Issue Type +	En	Location *	CR
Category	Supplemental			GPS Latitude/Longitude	
				Start	End
Item	DWR UCIP Field Study			38.734568 °	38.734568 °
				-121.660264 °	-121.660264 °
DWR ID					
Comment Code					
Inspector Comment					
FS_ID:46746					
DS_ID:17744					
EP_NO: 10284					
Repair Type: Non-Urgent					
Crossing Status: Indicator Found					
UCIP Comments: Found abandoned 42-inch CM pipe on LS berm of the levee. This was abandoned by farmer, how Unknown. need to have verified if removed or concreted					
FIELD_STRUCT_DESC: 42-inch CM drainpipe through levee 25.0 feet below crown. Slide gate on waterward end. (ABO No. 10284 - Hershey).					
O&M manual 127, Revision Year 2011					
FS Date: 10/6/2015 2:32:21 PM

Landside view: an abandoned CM pipe on LS berm of the levee.

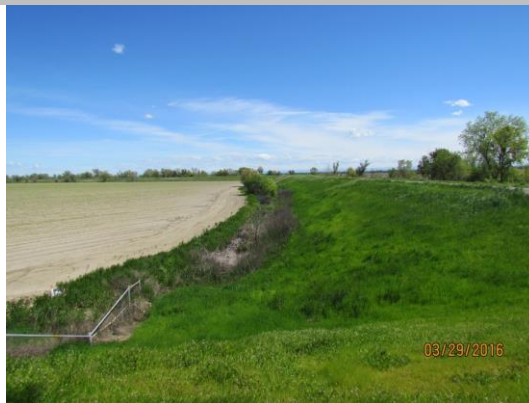
Photo 1 of 1 : SP_2016_ST0011_291_4_20160401_00011.jpg

LM Start	2.63	Rating **	M	Issue No.	4
LM End	2.72	Issue Type +	En	Location *	LS
Category	Earthen Levee			GPS Latitude/Longitude	
				Start	End
Item	Encroachments			38.724853 °	38.724228 °
				-121.663647 °	-121.665137 °
DWR ID	DWR_ST0011_01_s_2012_4				
Comment Code					
DT : Ditch					
Inspector Comment					
Ditch is at the toe of the levee.

View of the ditch at the toe of the levee on the landward side. Spring 2016.

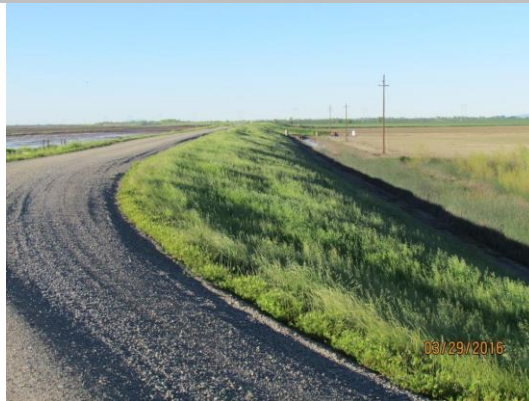
Photo 1 of 1 : SP_2016_ST0011_292_2_20160401_00006.jpg

LM Start	0.00	Rating **	M	Issue No.	2
LM End	1.51	Issue Type +	Ma	Location *	LS
Category	Earthen Levee			GPS Latitude/Longitude	
				Start	End
Item	Vegetation			38.719061 °	38.698695 °
				-121.664106 °	-121.674114 °
DWR ID	DWR_ST0011_02_s_2016_2				
Comment Code					
V1 : Control annual grass and weeds on the levee slopes and easements.					
Inspector Comment

View of the vegetation on the landward side of the levee looking downstream. Spring 2016.

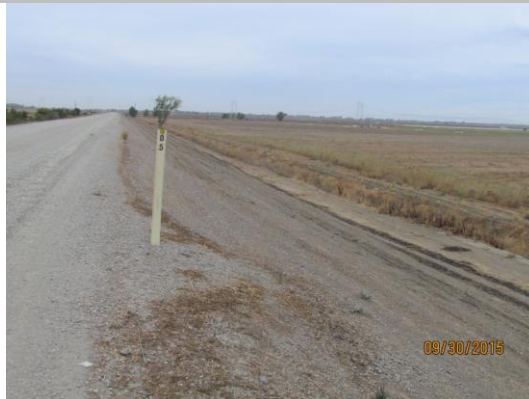
Photo 1 of 1 : SP_2016_ST0011_292_3_20160304_00001.jpg

LM Start	0.47	Rating **	M	Issue No.	3
LM End	0.97	Issue Type +	En	Location *	LS
Category	Earthen Levee			GPS Latitude/Longitude	
				Start	End
Item	Encroachments			38.712813 °	38.706018 °
				-121.667349 °	-121.670831 °
DWR ID	DWR_ST0011_02_s_2012_3				
Comment Code					
DT : Ditch					
Inspector Comment

View of the ditch at the landward side of the levee looking downstream. Fall 2015.

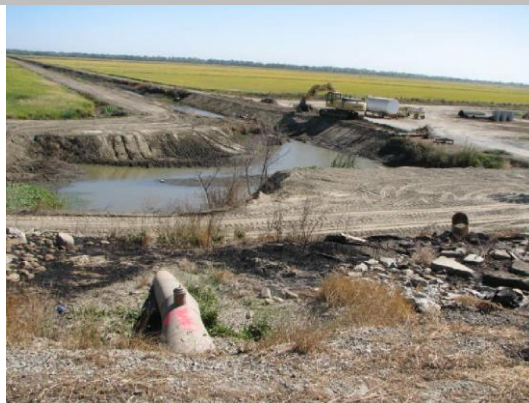
Photo 1 of 2 : UCIP_SP_2016_46742_60280.jpg

LM Start	0.98	Rating **	U	Issue No.	6
LM End	0.98	Issue Type +	En	Location *	LS
Category	Supplemental			GPS Latitude/Longitude	
				Start	End
Item	DWR UCIP Field Study			38.705952 °	38.705952 °
				-121.670875 °	-121.670875 °
DWR ID

Comment Code					
Inspector Comment					
FS_ID:46742 DS_ID:17749 EP_NO: 10288 Repair Type: Urgent Crossing Status: Found UCIP Comments: Sloughing at pipe day light on WS slope. A 8-inch pipe was not visible during field survey. Air vent leaking water when pump activated causing erosion around pipe on slope. summer of 2013 repaired sloughing around pipe air vent still leaking FIELD_STRUCT_DESC: 24 inch pipe through levee 5.2 feet below crown; a 8-inch pipe sleeved through the 24-inch pipe with the annular space grouted, a pump in a pumphouse at the toe of the landward slope, and a siphon breaker on the waterside slope. (ABO No. 10288 - Cache Creek Ranch). FS Date: 10/6/2015 2:30:10 PM

Waterside view: overview of pipe and water channel

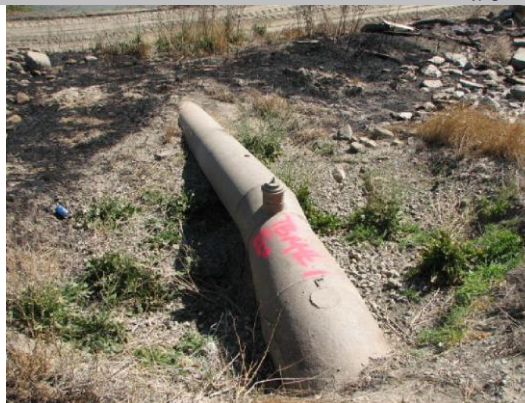
Photo 2 of 2 : UCIP_SP_2016_46742_60279.jpg

Comment Code						
Inspector Comment						
FS_ID:46742 DS_ID:17749 EP_NO: 10288 Repair Type: Urgent Crossing Status: Found UCIP Comments: Sloughing at pipe day light on WS slope. A 8-inch pipe was not visible during field survey. Air vent leaking water when pump activated causing erosion around pipe on slope. summer of 2013 repaired sloughing around pipe air vent still leaking FIELD_STRUCT_DESC: 24 inch pipe through levee 5.2 feet below crown; a 8-inch pipe sleeved through the 24-inch pipe with the annular space grouted, a pump in a pumphouse at the toe of the landward slope, and a siphon breaker on the waterside slope. (ABO No. 10288 - Cache Creek Ranch). FS Date: 10/6/2015 2:30:10 PM

Waterside view: pipe and siphon breaker

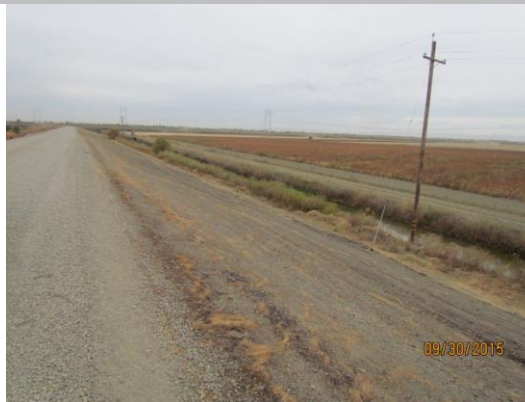
Photo 1 of 1 : SP_2016_ST0011_292_5_20160304_00002.jpg

LM Start	1.15	Rating **	M	Issue No.	5
LM End	1.44	Issue Type +	En	Location *	LS
Category	Earthen Levee			GPS Latitude/Longitude	
				Start	End
Item	Encroachments			38.703681 °	38.699637 °
				-121.672090 °	-121.674112 °
DWR ID	DWR_ST0011_02_s_2012_5				
Comment Code					
DT : Ditch					
Inspector Comment					
The ditch is at the toe of the levee.

View of the ditch on the landward side of the levee looking downstream.
Fall 2015.

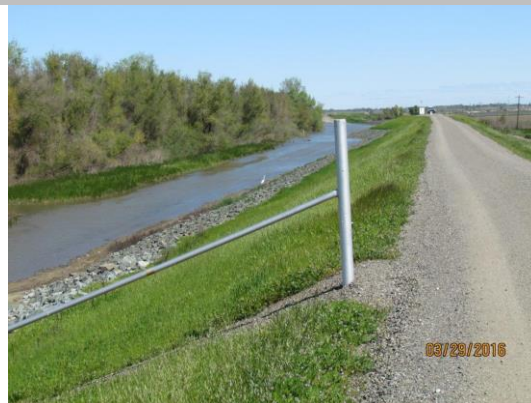
Photo 1 of 1 : SP_2016_ST0011_293_2_20160401_00001.jpg

LM Start	0.00	Rating **	M	Issue No.	2
LM End	1.41	Issue Type +	Ma	Location *	WS
Category	Earthen Levee			GPS Latitude/Longitude	
				Start	End
Item	Vegetation			38.698571 °	38.678241 °
				-121.674122 °	-121.672962 °
DWR ID	DWR_ST0011_03_s_2016_2				
Comment Code					
V1 : Control annual grass and weeds on the levee slopes and easements.					
Inspector Comment

View of the vegetation on the waterward side of the levee looking downstream. Spring 2016.

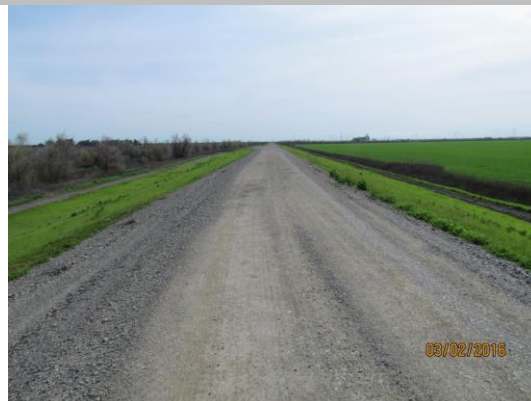
Photo 1 of 1 : SP_2016_ST0011_294_14_20160303_00010.jpg

LM Start	0.00	Rating **	M	Issue No.	14
LM End	0.07	Issue Type +	Ma	Location *	CR
Category	Earthen Levee			GPS Latitude/Longitude	
				Start	End
Item	Crown Surface / Depressions / Rutting			38.574293 °	38.573315 °
				-121.638713 °	-121.638742 °
DWR ID	DWR_ST0011_04_s_2016_14				
Comment Code					
C3 : Add appropriate gravel or road base. Grade and compact.					
Inspector Comment					
Crown needs to be regraded.

View of the crown of the levee looking downstream. Spring 2016.

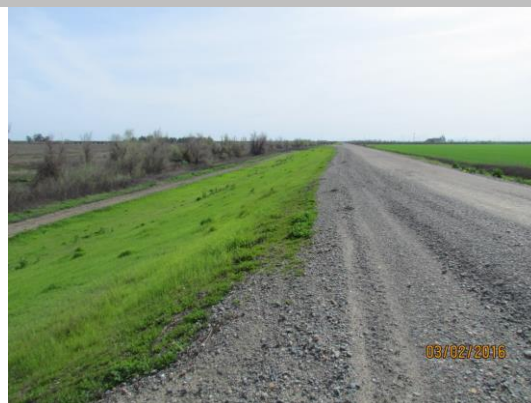
Photo 1 of 1 : SP_2016_ST0011_294_12_20160303_00012.jpg

LM Start	0.00	Rating **	A	Issue No.	12
LM End	0.63	Issue Type +	Ma	Location *	WS
Category	Earthen Levee			GPS Latitude/Longitude	
				Start	End
Item	Vegetation			38.574293 °	38.565303 °
				-121.638713 °	-121.638440 °
DWR ID	DWR_ST0011_04_s_2016_12				
Comment Code					
V1 : Control annual grass and weeds on the levee slopes and easements.					
Inspector Comment					
Vegetation on slopes have been maintained by the LMA.

View of the vegetation on the waterward side of the levee looking downstream. Spring 2016.

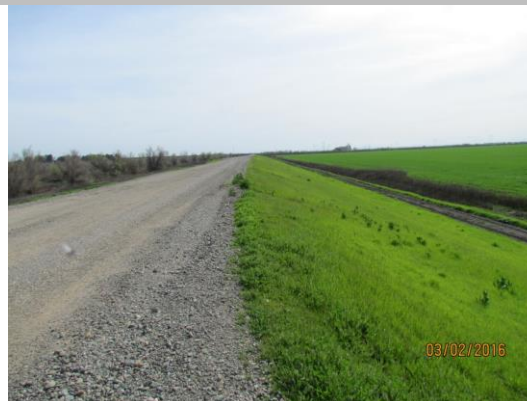
Photo 1 of 1 : SP_2016_ST0011_294_13_20160303_00011.jpg

LM Start	0.00	Rating **	A	Issue No.	13
LM End	0.63	Issue Type +	Ma	Location *	LS
Category	Earthen Levee			GPS Latitude/Longitude	
				Start	End
Item	Vegetation			38.574293 °	38.565303 °
				-121.638713 °	-121.638440 °
DWR ID	DWR_ST0011_04_s_2016_13				
Comment Code					
V1 : Control annual grass and weeds on the levee slopes and easements.					
Inspector Comment					
Vegetation on slope has been maintained by LMA.

View of the vegetation on the landward side of the levee looking downstream. Spring 2016.

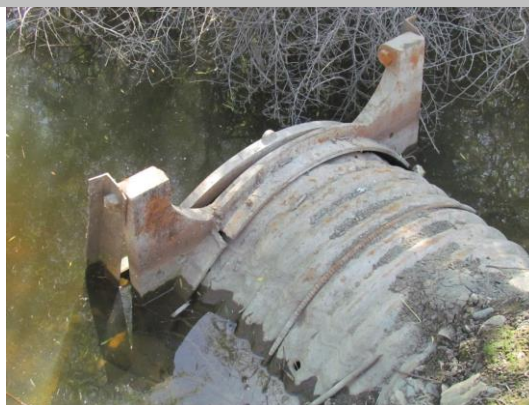
Photo 1 of 2 : SP_2016_ST0011_294_2_20160302_00001.jpg

LM Start	0.78	Rating **	M	Issue No.	2 (cont)
LM End	0.78	Issue Type +	Ma	Location *	WS

View of the flap gate in the ditch on the water side of the levee. There seems to be debris preventing the flap gate from closing. Spring 2015.

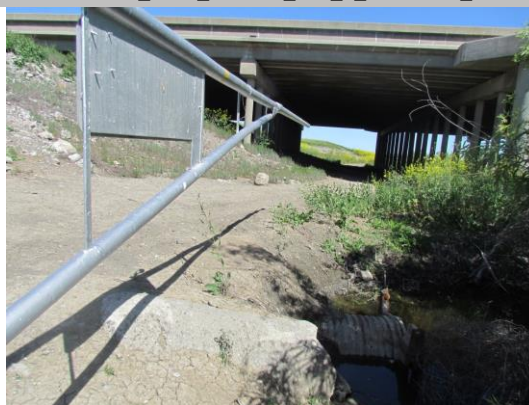
Photo 2 of 2 : SP_2016_ST0011_294_2_20160302_00002.jpg

View of a perspective on the pipe looking upstream. Spring 2015.

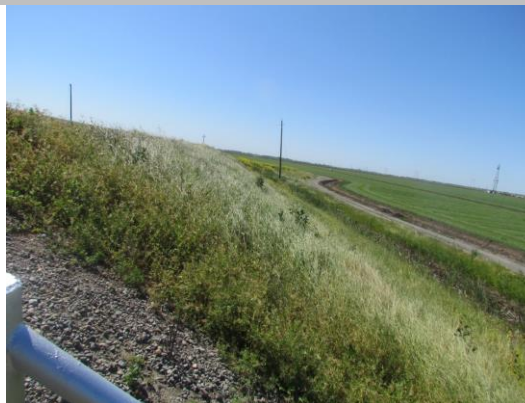
Photo 1 of 1 : SP_2016_ST0011_294_6_20160302_00009.jpg

LM Start	0.91	Rating **	M	Issue No.	6
LM End	1.03	Issue Type +	En	Location *	LS
Category	Earthen Levee			GPS Latitude/Longitude	
				Start	End
Item	Encroachments			38.561233 °	38.559502 °
				-121.638182 °	-121.637810 °
DWR ID	DWR_ST0011_04_s_2015_6				
Comment Code					
DT : Ditch					
Inspector Comment					
The ditch is at the toe of the levee on the landward side.

View of the ditch on the landward side of the levee looking downstream. Spring 2015.

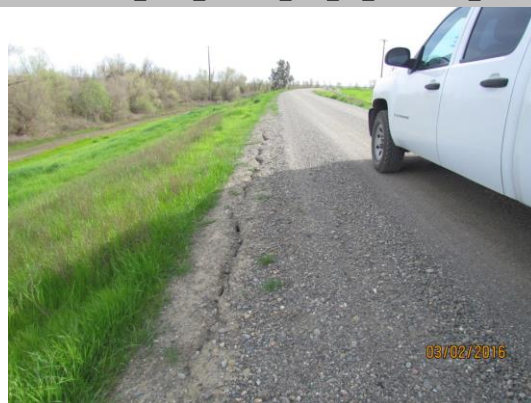
Photo 1 of 1 : SP_2016_ST0011_294_20_20160303_00013.jpg

LM Start	1.57	Rating **	M	Issue No.	20
LM End	1.57	Issue Type +	Ma	Location *	WS
Category	Earthen Levee			GPS Latitude/Longitude	
				Start	End
Item	Cracking			38.553105 °	38.553105 °
				-121.632170 °	-121.632170 °
DWR ID	DWR_ST0011_04_s_2016_20				
Comment Code					
CR1 : Monitor and have inspected by geotechnical engineer.					
Inspector Comment

View of the crack on the waterward shoulder of the levee looking downstream. Spring 2016.

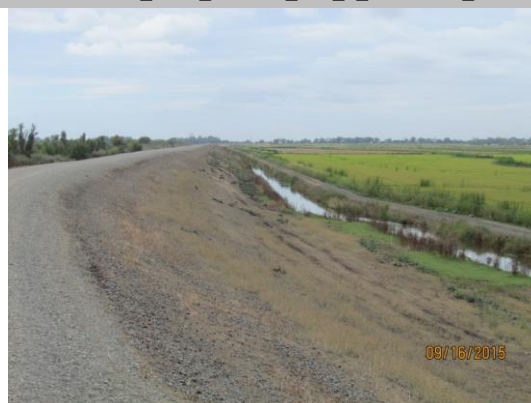
Photo 1 of 1 : SP_2016_ST0011_294_3_20160302_00004.jpg

LM Start	1.77	Rating **	M	Issue No.	3
LM End	2.69	Issue Type +	En	Location *	LS
Category	Earthen Levee			GPS Latitude/Longitude	
				Start	End
Item	Encroachments			38.550387 °	38.536958 °
				-121.631257 °	-121.631450 °
DWR ID	DWR_ST0011_04_s_2012_3				
Comment Code					
DT : Ditch					
Inspector Comment					
The ditch is at the toe of the levee on the landward side.

View of the ditch along the levee toe on the landward side of the levee looking downstream. Fall 2015.

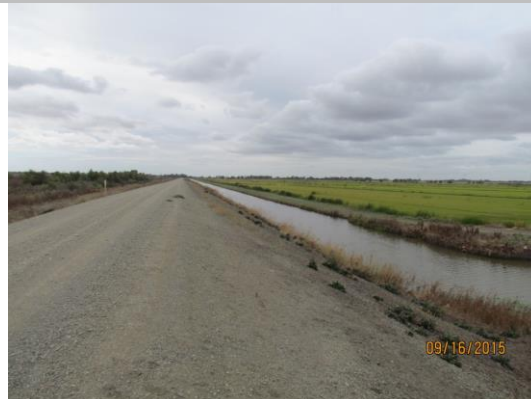
Photo 1 of 2 : SP_2016_ST0011_294_4_20160302_00007.jpg

LM Start	2.75	Rating **	M	Issue No.	4 (cont)
LM End	3.60	Issue Type +	En	Location *	LS

The ditch is at the levee toe on the landward side of the levee looking downstream. Fall 2015.

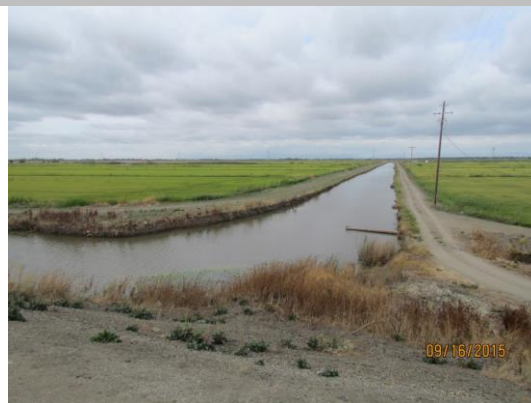
Photo 2 of 2 : SP_2016_ST0011_294_4_20160302_00008.jpg

Looking west at the agricultural ditch. Fall 2015.
